— FORENSIC ROOF REPORT · FOR PERMIT APPLICATION

# Forensic Roof Inspection Report

PROPERTY OF RECORD  
**1847 Sample Ridge Drive**  
*Kyle, TX 78640 · Hays County*

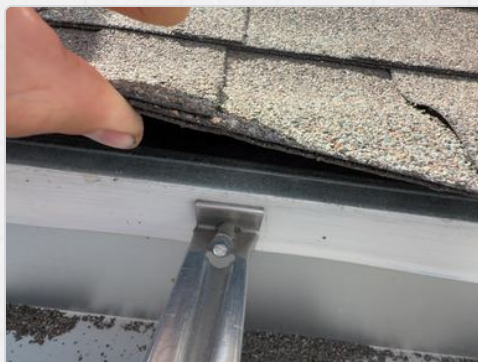
### FINDING 1

At the eave/gutter line, I observed granules and small asphalt fragments accumulated in the gutter below the architectural asphalt shingles, consistent with hail-impact-related granule displacement at this area.

**Corroborating references:** Haag Engineering Co. — *Mat Rupture / Granule Displacement*: "Hail-caused damage...[includes] displacement of granules sufficient to expose underlying bitumen...[and] reduces the expected service life of the material."; The Institutes (AICPCU) — *Granule Displacement Curtails Shingle Life*: "Hail damage can cause displacement of granules sufficient to expose underlying bitumen...could curtail the expected life of the shingle..."

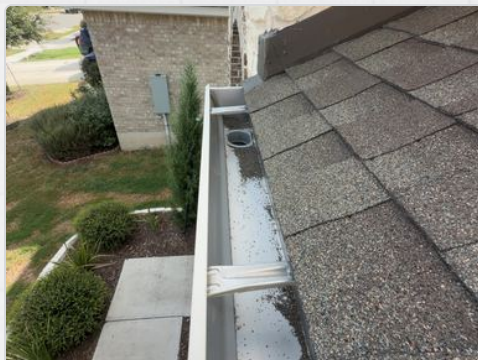
### FINDING 2

Along the same eave and gutter run, I observed a consistent concentration of shingle granules distributed in the gutter across this section, documenting a repeated pattern of granule displacement consistent with hail-impact effects in this area.

**Corroborating references:** Haag Engineering Co. — *Mat Rupture / Granule Displacement*: "Hail-caused damage...[includes] displacement of granules sufficient to expose underlying bitumen...[and] reduces the expected service life of the material."; The Institutes (AICPCU) — *Bruising and Puncturing Defined*: "May include loss of surface granules... Roof edges... are susceptible to bruising."

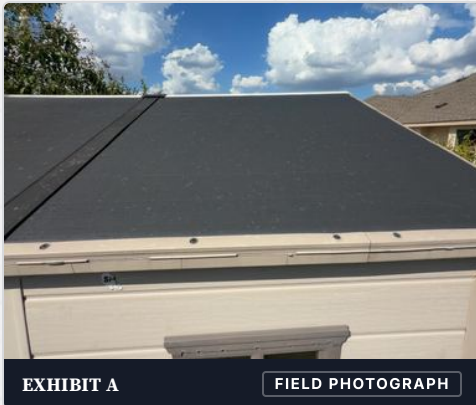
### FINDING 3

I observed numerous small, circular hail impact dents distributed randomly across the flat pan/field area of the standing-seam metal roof panel on the outbuilding/shed, consistent with hail impact denting.

**Corroborating references:** *The Institutes (AICPCU), "Random Distribution Indicates Hail"*

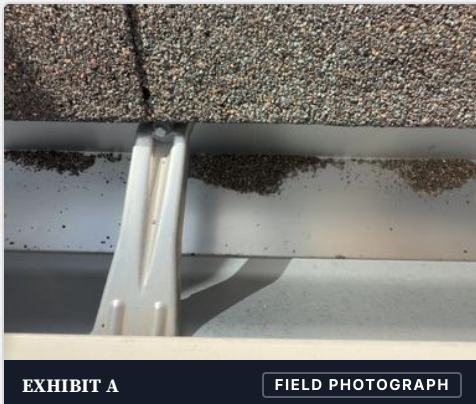
### FINDING 4

At the shingle eave course above the metal gutter edge, I observed a discrete hail impact with granule displacement and a small split/fracture in the shingle surface, consistent with functional hail damage to an architectural asphalt shingle.

**Corroborating references:** *Haag Engineering Co., "Functional Damage: Punctures, Tears, Fractures"; Haag Engineering Co., "Mat Rupture / Granule Displacement"; The Institutes (AICPCU), "Granule Displacement Curtails Shingle Life"*

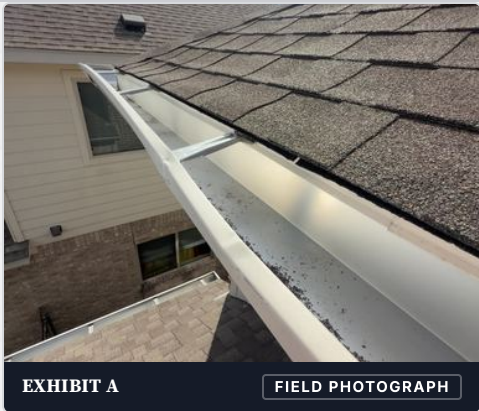
### FINDING 5

I observed granule debris collected in the gutter trough along the eave beneath the shingle drip edge, consistent with roof-surface debris accumulation associated with impact activity on the roof slope above.

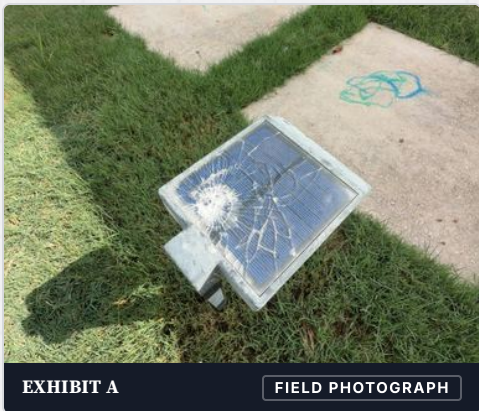
**FINDING 6**  
I observed a shattered solar path light lens/top with multiple radiating fractures, consistent with impact-related breakage at this location.

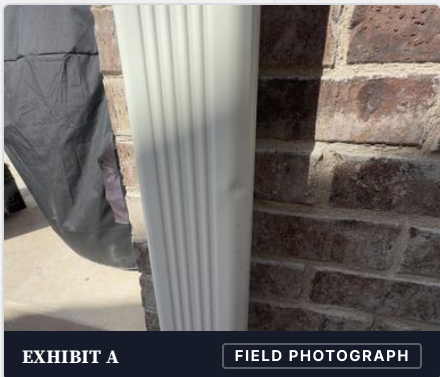
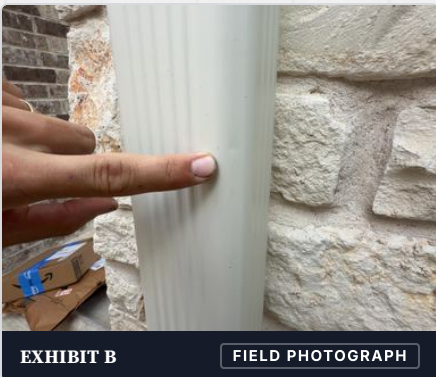
**FINDING 7**  
I observed localized shallow impact deformation/creasing to the painted metal downspout at a brick corner, with associated speckled spatter/spotting at and around the same area consistent with storm-related impact marking on the finish.

5. **Gutters and downspouts with observed impact denting/spatter/spotting** — Evaluate for replacement/restore of storm-impacted exterior drainage components as part of exterior storm restoration. *In the Documented Findings section, I documented localized denting and spatter/spotting on downspouts and impact-related granule/debris accumulation at the eaves/gutter line beneath the roof slopes.*

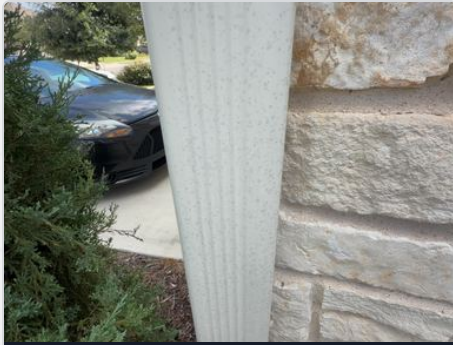
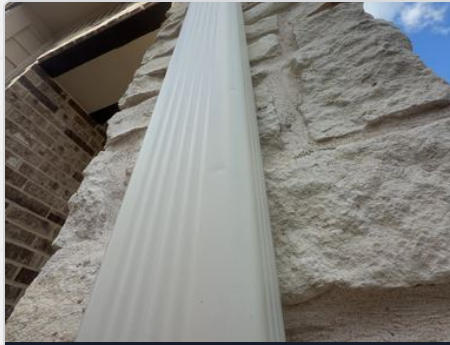
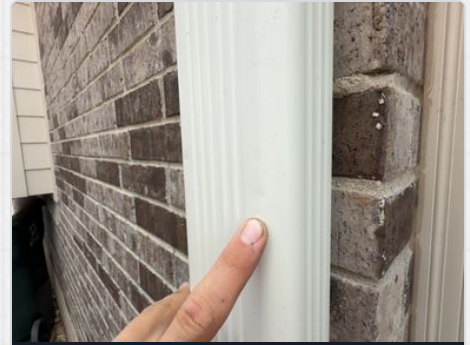
**FINDING 8**  
I observed scattered small speckled spatter/spotting distributed across multiple views of the downspout face along the corner run, consistent with repeated small impact marks on the painted surface.

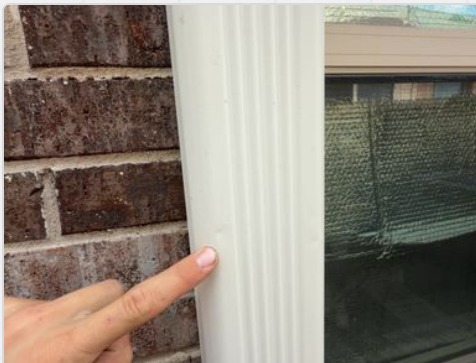
**FINDING 9**

I observed a localized paint displacement/scuff on the face of the downspout at the area I indicated for scale, consistent with an impact/abrasion mark to the coating.

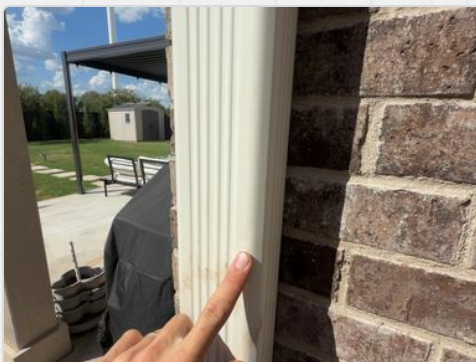
**FINDING 10**

I observed a small linear crack/separation at a sealant/joint area on the downspout at the corner location I indicated for scale.

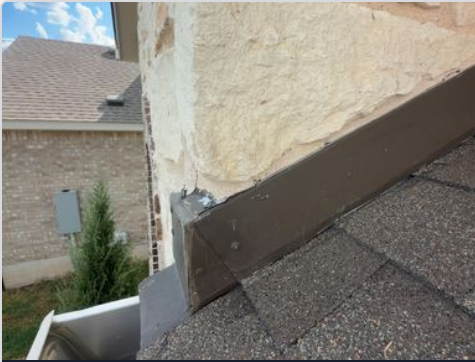
I observed localized separation/opening at the roof-to-wall flashing corner where the metal apron/step flashing and adjacent counterflashing meet the wall surface, with separation visible along the sealed joint line at the masonry interface.

**Corroborating references:** *International Code Council, IRC R905.2.8.1 (Base and Cap Flashing)*

3. **Roof flashings at sidewalls/roof-to-wall transitions (apron/step flashing and counterflashing interfaces as present)** — Evaluate for replacement of roof-to-wall and transition flashings concurrent with reroofing. *In the Documented Findings section, I documented storm-related impact indications and deformation/spotting at flashing areas. Flashing is integral to the roof system and is addressed in the Applicable Codes and Standards section (including IRC R905.2.8.1 Base and Cap Flashing and R905.2.8.3 Sidewall Flashing).*

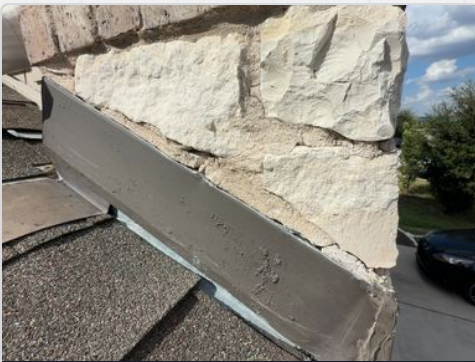
## FINDING 12

I observed metal counterflashing at a masonry sidewall with localized gaps/separation along the sealant line at the termination corner at the masonry interface.

**Corroborating references:** *International Code Council, IRC R905.2.8.1 (Base and Cap Flashing)*

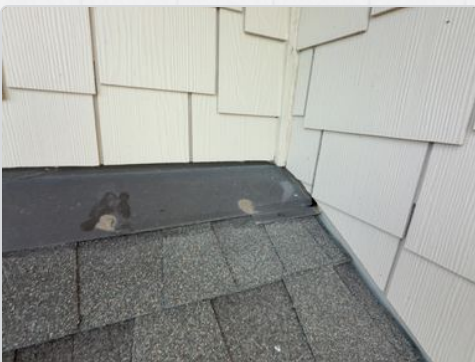
## FINDING 13

I observed localized separation/open gaps along the sealant line at the roof-to-wall transition where metal flashing/apron meets the wall at the base of lap siding, including at a flashing lap at the corner.

**Corroborating references:** *International Code Council, IRC R905.2.8.3 (Sidewall Flashing)*

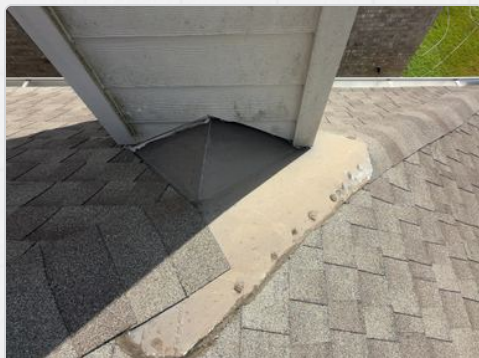
**FINDING 14**

I observed cracking/voids and irregular breaks in the sealant/mastic band at a metal base-flashing/penetration area surrounded by architectural shingles, with corrosion staining/spotting also visible on portions of the metal flashing near the lower edge.

**Corroborating references:** *International Code Council, IRC R905.2.8.1 (Base and Cap Flashing)*

4. **Roof penetrations and metal flashings/boots (vents, pipe flashings, related metal surfaces)** — Evaluate for replacement of roof-penetration flashings/metal components that show impact indications. *In the Documented Findings section, I documented impact indications on roof-related metal components (including denting/spatter on a metal vent/flashing surface). Coordinating these items with the reroof scope supports continuity of the weather-resistant system consistent with IRC reroofing provisions cited in the Applicable Codes and Standards section (R908.1 and R908.3).*

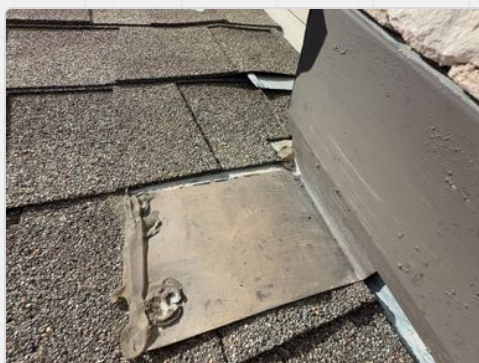
**FINDING 15**

I observed physical deformation/disturbance of the exposed metal flashing at the roof-to-wall/step-flashing area (lower left of the documented area), along with split/displaced sealant at the flashing edge and localized surface corrosion/oxidized areas on the metal.

**Corroborating references:** *International Code Council, IRC R905.2.8.3 (Sidewall Flashing)*

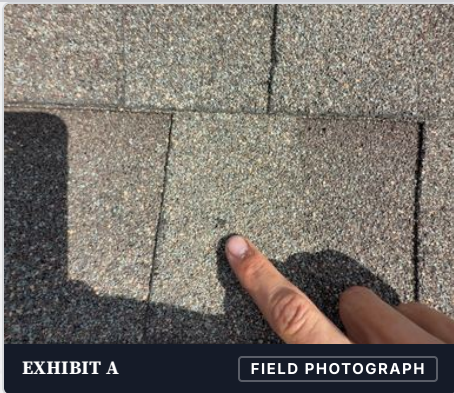
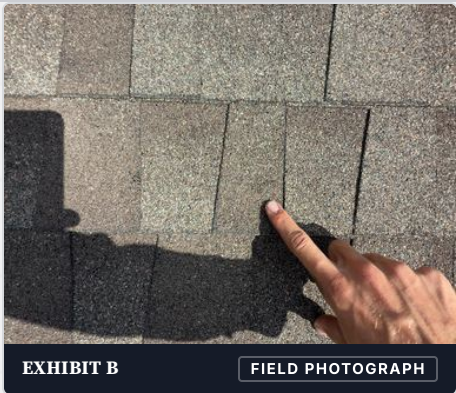
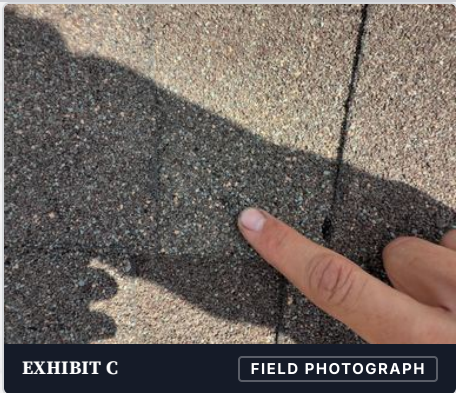
**FINDING 16**

I observed linear splits/tears through the surface of the architectural asphalt shingles at multiple field locations (including at/near shingle joints/keyways), consistent with fracture-type damage to the shingle surfacing.

**Corroborating references:** *Haag Engineering Co. — Functional Damage: Punctures, Tears, Fractures; Haag Engineering Co. — Age-Related Anomalies (Not Hail)*

- 06** I observed localized splits/tears within the shingle surfacing at select field locations (including at/near vertical keyways), including locations where fractures coincided with impact-related granule disturbance.

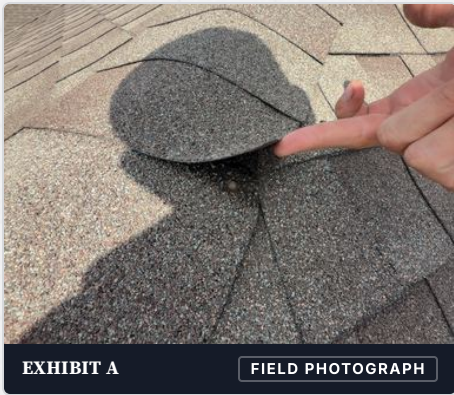
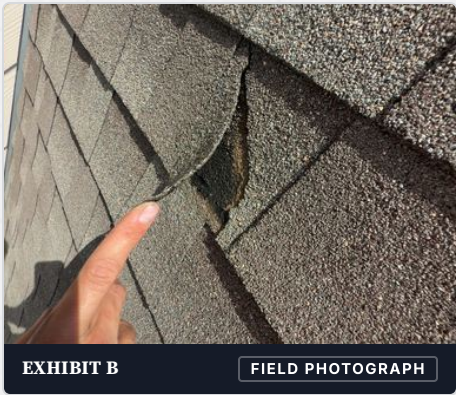
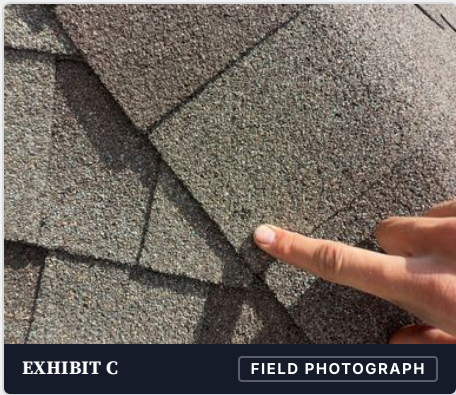
**FINDING 17**

I observed wind-affected shingle lifting where shingle leading edges/tabs were raised and not lying flush to the course below. In one area, I also observed a crease line at/near the lifted tab with the underlying sealant/adhesive strip area visible adjacent to the lift location.

**Corroborating references:** *Donan Engineering — A Broken Seal Never Fully Re-Adheres*

- 05** I observed wind-related shingle conditions including lifted/unsealed tab edges and, in at least one area adjacent to sidewall/apron flashing, creased shingles consistent with wind-uplift flexing.

2. **Wind-creased and lifted-tab areas observed in the shingle field (including eaves and field areas adjacent to wall/flashings)** — Evaluate for replacement of wind-affected shingles within the overall reroof scope. *In the Documented Findings section, I documented lifted/unsealed tabs and creased shingles consistent with wind-uplift effects. Within a sealed shingle system, replacing affected shingles without compromising adjacent seals is not reliably achievable; broken seals do not regain original adhesion (Donan Engineering, see the Applicable Codes and Standards section).*

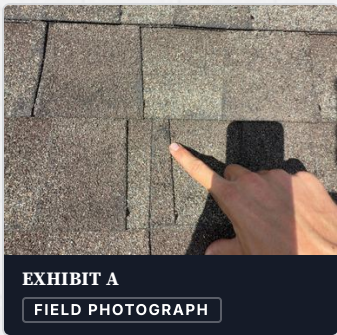
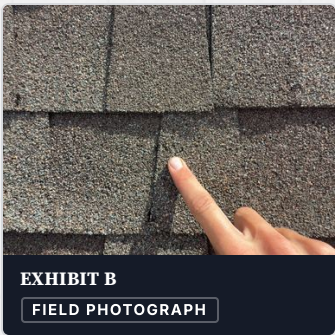
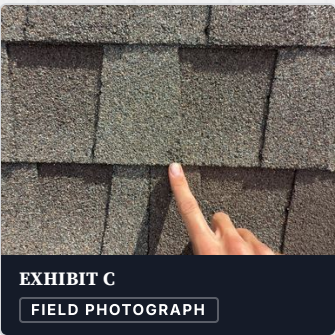
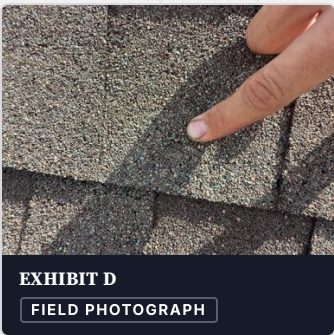
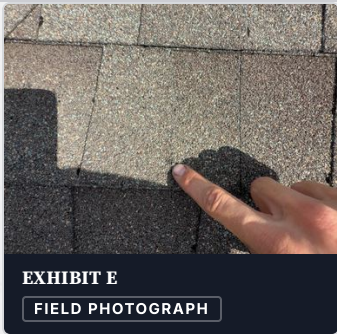
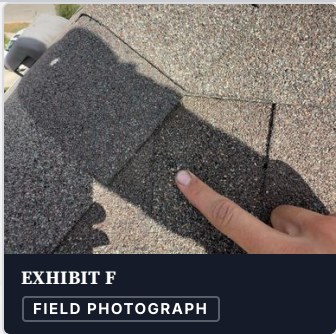
**FINDING 18**

I observed multiple localized hail-impact marks on the CertainTeed architectural asphalt shingles, including distinct impact spots with granule displacement and bruising that contrasted with adjacent, undisturbed surfacing.

**Corroborating references:** *Haag Engineering Co. — Mat Rupture / Granule Displacement; The Institutes (AICPCU) — Granule Displacement Curtails Shingle Life*

- 01** I observed multiple hail-impact marks on the CertainTeed architectural asphalt shingles, including discrete impact spots with granule displacement and bruise-like signatures that contrasted with adjacent, undisturbed surfacing.

1. **Asphalt shingle roof covering — all slopes (Front, Right, Rear, Left)** — Evaluate for full replacement of the roof covering on all slopes (complete tear-off and reroof as customary for replacement projects). *In the Documented Findings section, I documented hail-impact indicators on the shingle field (granule displacement and localized mat exposure) with storm activity most concentrated on the left slope per my inspection notes. Because asphalt shingles function as an interlocked, sealed system, selective replacement requires disturbing adjacent sealed courses; Donan Engineering notes a broken seal never fully re-adheres to its prior bond strength, and NAFE notes the roof must be evaluated as a system. Reroofing work is governed by IRC R908 (see the Applicable Codes and Standards section).*

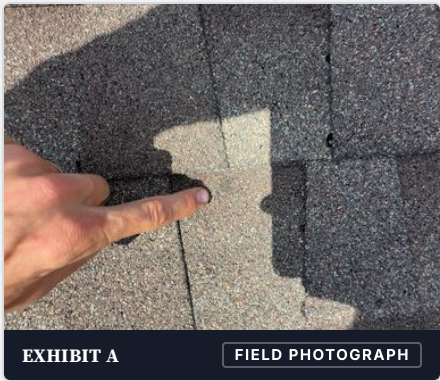
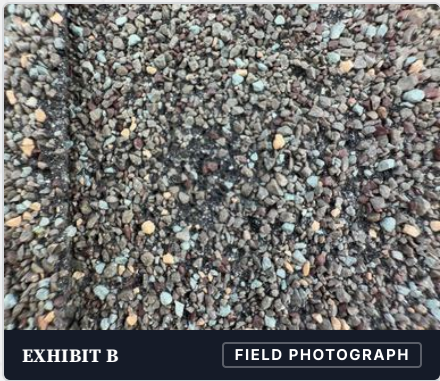
**FINDING 19**

I observed hail-impact locations with localized mat exposure at the strike point, indicating granule loss sufficient to expose the underlying asphalt/fiberglass mat/bitumen at those discrete impact areas.

**Corroborating references:** *Haag Engineering Co. — Mat Rupture / Granule Displacement; The Institutes (AICPCU) — Bruising and Puncturing Defined*

- 02** I observed discrete hail-impact locations with localized mat exposure at the strike point in the shingle field, indicating granule loss sufficient to expose underlying bitumen/mat at those impact areas.

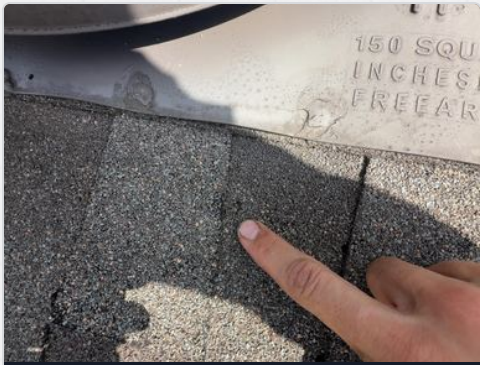
**FINDING 21**

I observed localized denting/deformation on the metal roof vent/flashing with associated coating/paint displacement and spatter spotting at the dented locations, consistent with storm-related impact to the metal surface.

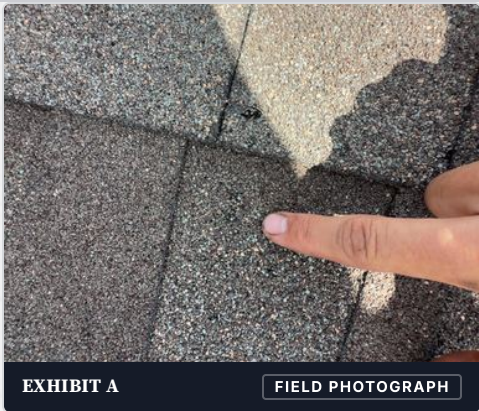
**FINDING 22**

I observed a localized, darkened impact/bruise-like spot on an architectural asphalt shingle at the area I indicated, consistent with a discrete impact point on the shingle surfacing.
