# Roof Inspection Report

1847 Sample Ridge Drive, Kyle, TX 78640

HAIL & WIND DAMAGE

| INSPECTION | September 2, 2026 |

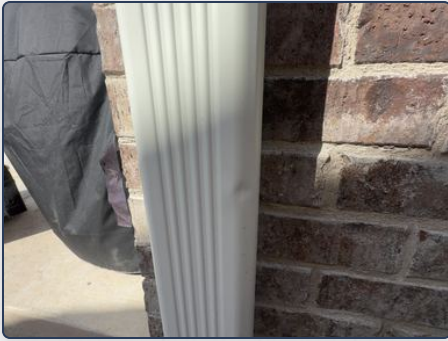
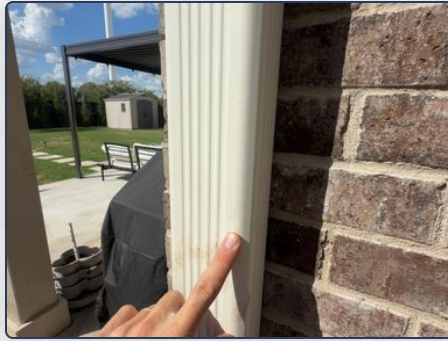
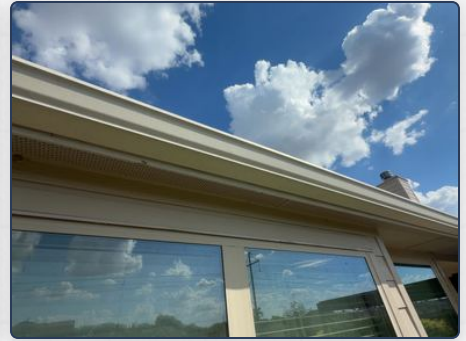
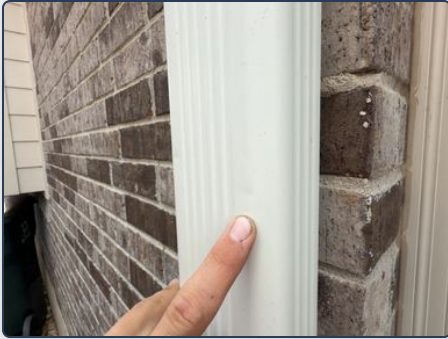
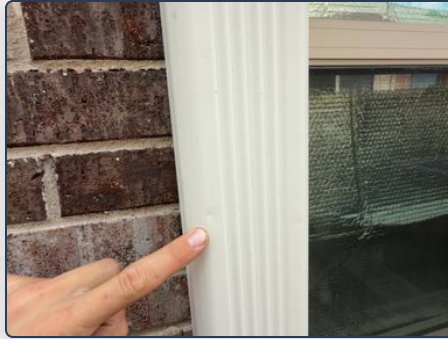
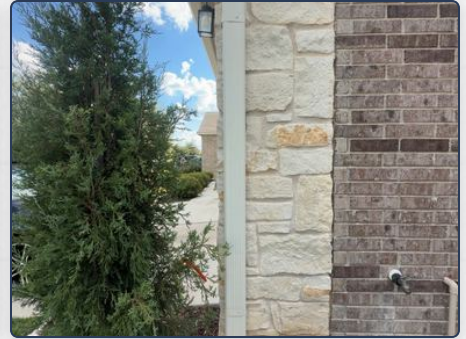
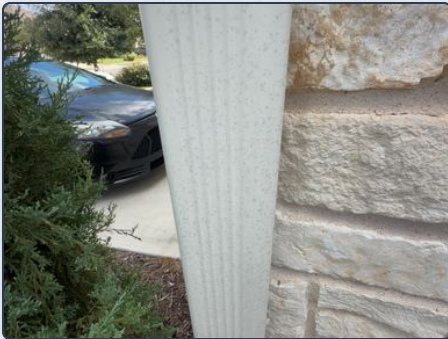
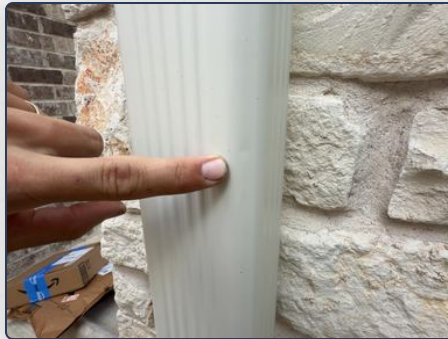
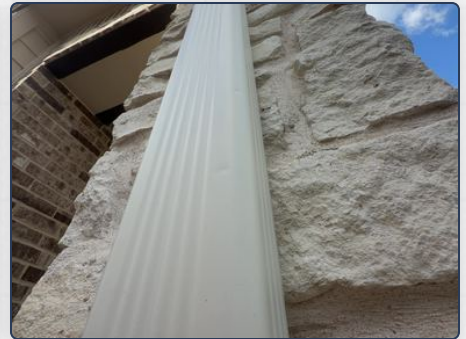
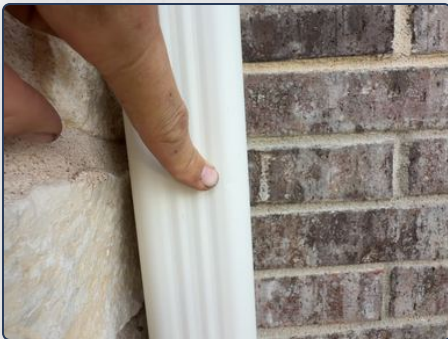
## Gutters & Downspouts

I documented minor denting on downspout surfaces consistent with soft-metal impact damage. While some downspout photos show speckling that appears consistent with surface spotting rather than deformation, the documented denting areas warrant repair or replacement of affected sections to restore appearance and ensure proper drainage alignment.

- Minor denting was documented on downspout faces, consistent with soft-metal impact damage.
- Downspout and gutter components were documented at multiple elevations for condition verification and repair scoping.

Repair or replace downspout sections showing denting and confirm gutter/downspout alignment and secure fastening at impacted locations.

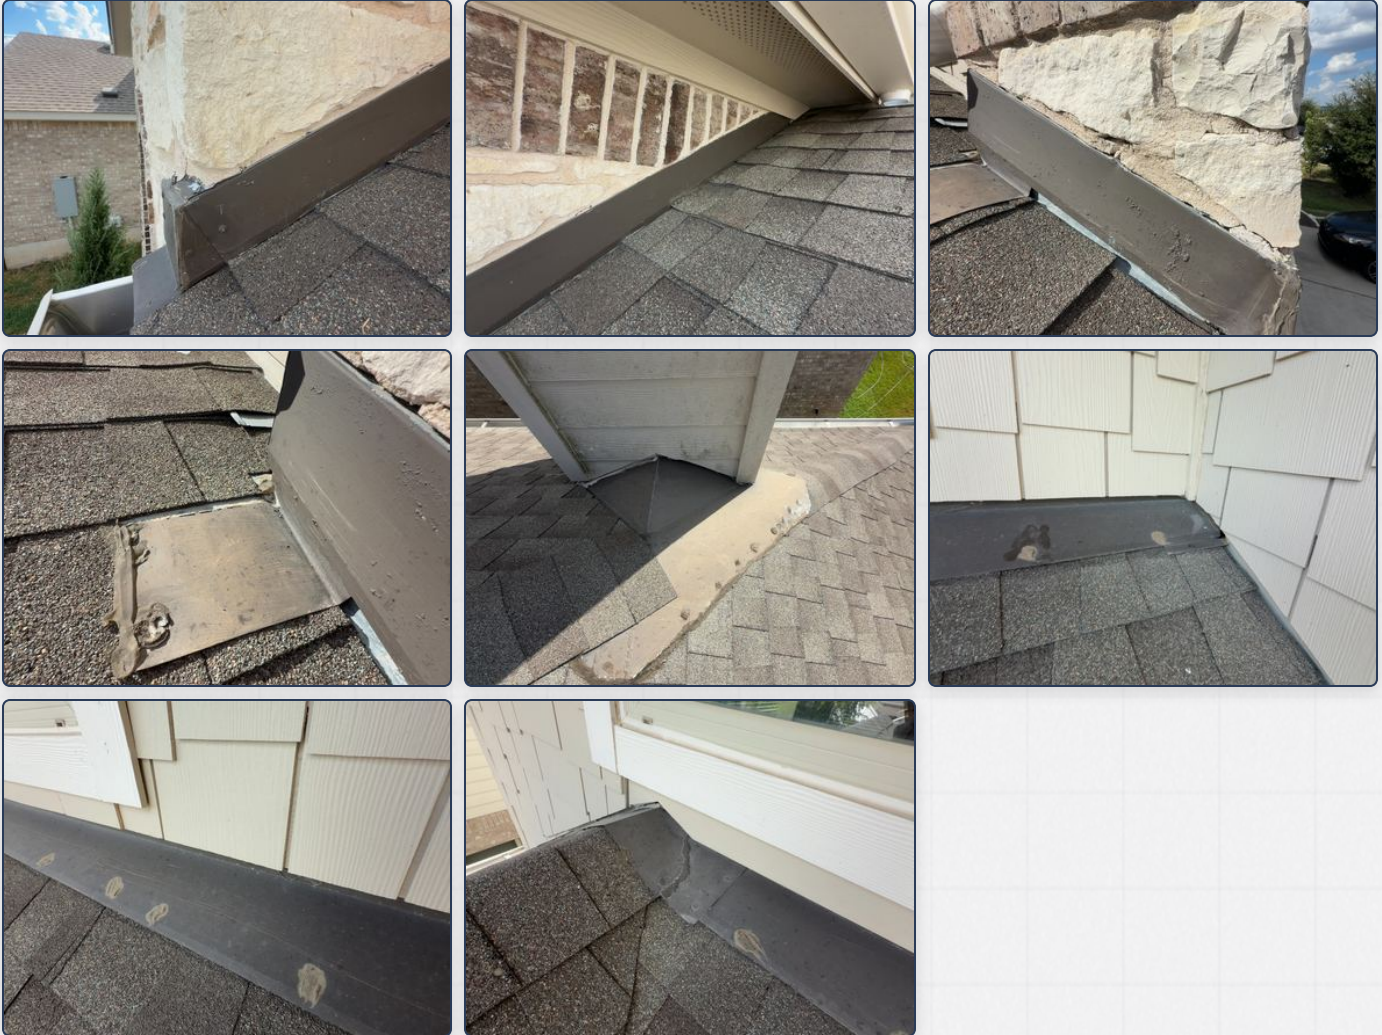
# Flashing

I documented storm-consistent collateral on roof flashings, including spatter on roof-to-wall flashing. I also documented wind-related shingle creasing on the roof surface in this section, indicating uplift/flexing occurred in the affected area. Several roof-to-wall locations showed heavy or irregular sealant/roofing cement at the flashing line, which should be properly re-detailed to reduce leak vulnerability.

- Spatter was documented on roof-to-wall flashing, consistent with hail impacts on soft metal surfaces.
- Wind-related creasing was documented across multiple shingles, consistent with wind-uplift flexing.
- Irregular/heavy sealant and patching was documented at roof-to-wall flashing transitions, indicating vulnerable detailing that should be corrected during repairs.

Replace or re-detail roof-to-wall flashing areas where spatter and irregular/heavy sealant or roofing cement were documented, ensuring proper step/apron flashing integration with shingles and reliable terminations.

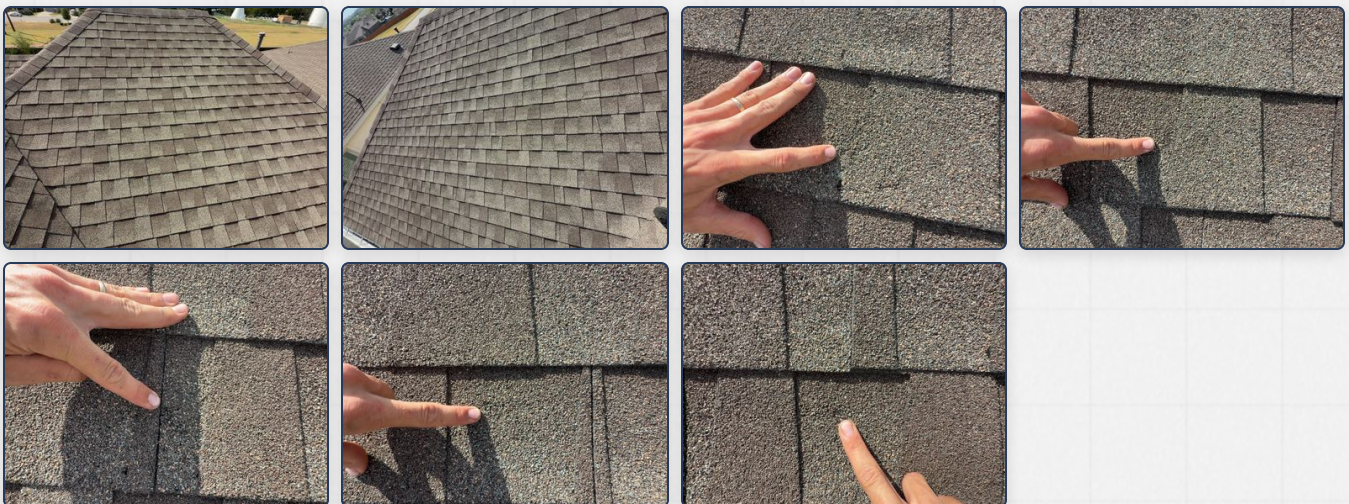
**Front****7 PHOTOS****SEVERITY · MODERATE**

On the Front roof plane, I documented hail impacts as scattered, including multiple views where isolated rounded impact signatures interrupt an otherwise uniform granule field. The photographed areas include close-ups used to confirm individual impacts as well as wider context shots used to show distribution across the plane.

- Hail impacts were documented on the Front roof plane in a scattered pattern.

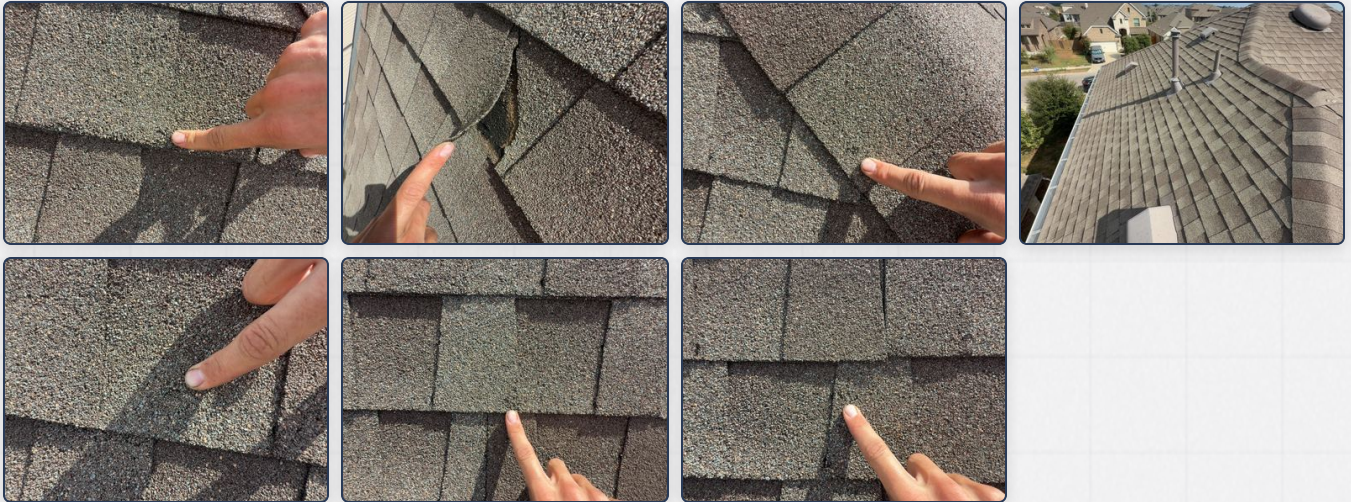
**Right****7 PHOTOS****SEVERITY · SIGNIFICANT**

On the Right roof plane, I documented wind-related shingle distress including lifted/unsealed tab edges and creasing on individual shingles. These conditions indicate loss of adhesion and prior flexing, which

can reduce wind resistance and increase water entry potential at laps and fasteners. Hail impacts were also documented in close-ups in this instance's photo set.

- Lifted/unsealed tabs and creased shingles were documented on the Right roof plane, consistent with wind-uplift stress.
- Hail impacts were documented on the Right roof plane in localized close-ups.

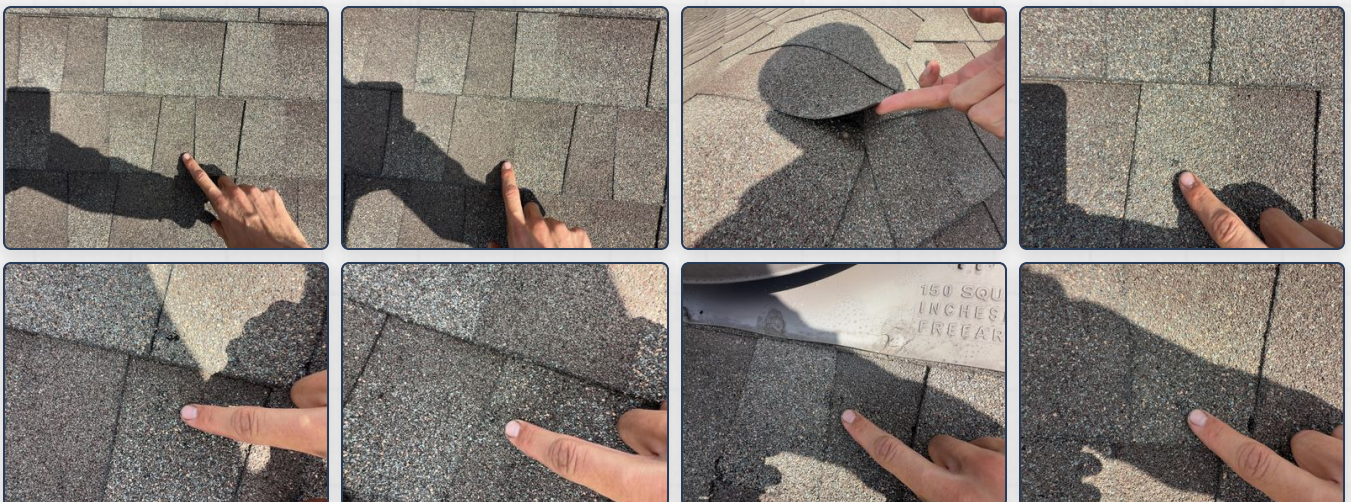
**Rear****12 PHOTOS****SEVERITY · MODERATE**

On the Rear roof plane, I documented hail impacts in a scattered pattern across multiple courses. The photo set includes both wide-field roof-plane views and close-ups used to confirm individual impact signatures.

- Hail impacts were documented on the Rear roof plane in a scattered pattern.
