— FORENSIC ROOF REPORT · FOR PERMIT APPLICATION

# Forensic Roof Inspection Report

PROPERTY OF RECORD  
**1847 Sample Ridge Drive**  
*Kyle, TX 78640 · Hays County*

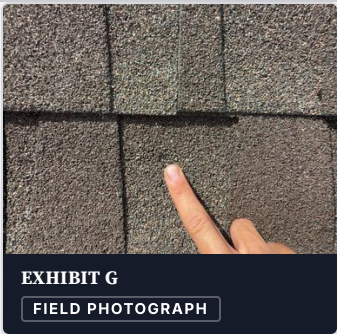
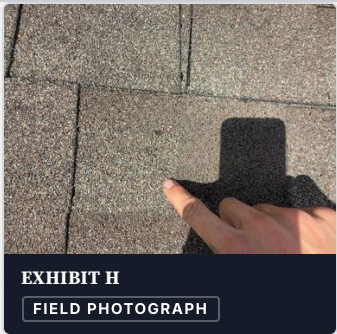
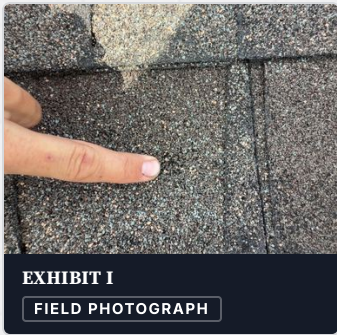
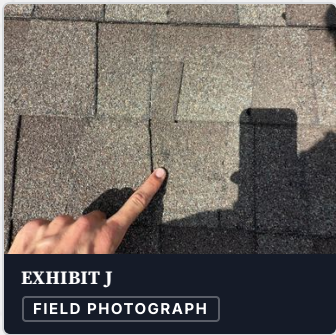
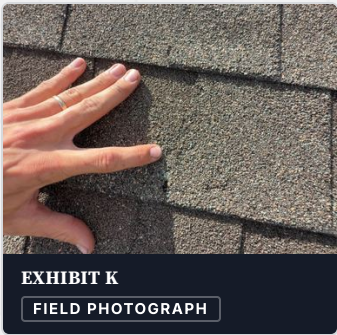
I observed multiple localized hail-impact marks on the CertainTeed architectural asphalt shingles, including distinct impact spots with granule displacement and bruising that contrasted with adjacent, undisturbed surfacing.

**Corroborating references:** *Haag Engineering Co. — Mat Rupture / Granule Displacement; The Institutes (AICPCU) — Granule Displacement Curtails Shingle Life*
